FOFFEL LAKE DAM
JOHNSON COUNTY, MISSOURI
MISSOURI INVENTORY NO. 20494

PHASE I INSPECTION REPORT
NATIONAL DAM SAFETY PROGRAM

PREPARED BY:
BLACK & VEATCH
CONSULTING ENGINEERS
KANSAS CITY, MISSOURI

DECEMBER 1980

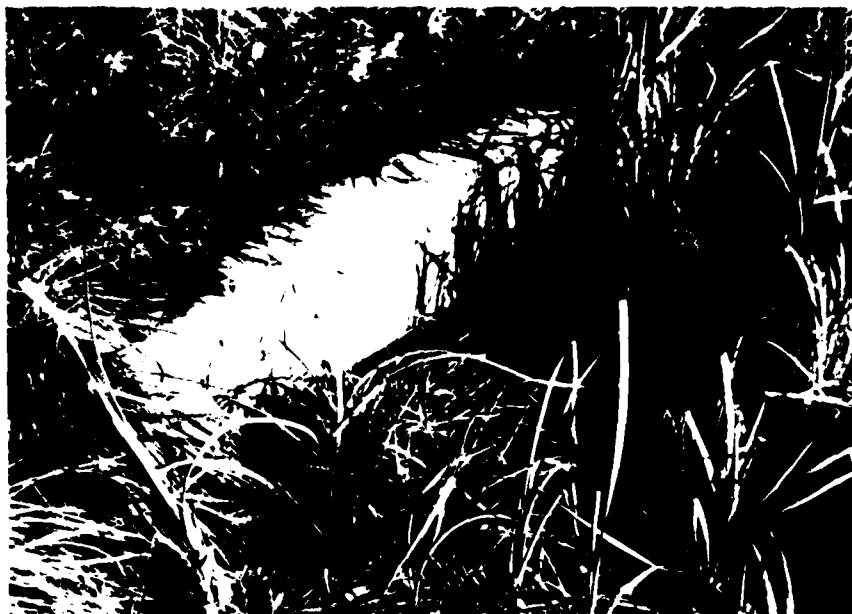
PHOTO 15: OUTLET FROM HIGHWAY CULVERT

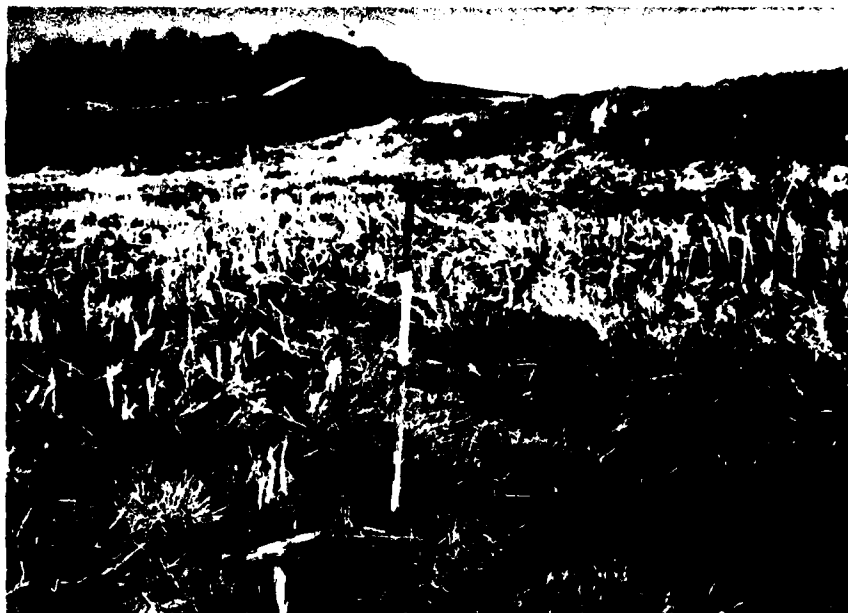
A seepage area was observed on the downstream slope of the embankment near the toe. Wet soils and standing water have provided an area for cattail growth. Clear flow of less than 1 gpm was observed at the lower end of the seepage area. No toe drains or relief wells were observed.

The area of seepage on the downstream slope which was observed should be monitored regularly for quality and quantity. Seepage can cause internal erosion creating cavities and underground channels, thereby weakening the embankment and/or abutments.

PHOTO 17: SEEPAGE AREA AT DOWNSTREAM TOE OF DAM

(2) The seepage area noted during the visual inspection should be closely monitored and documented as to quantity and quality of flow. Any significant changes should be evaluated.
